**US Army Corps  
of Engineers**  
New Orleans District

**EVALUATION OF THE  
NATIONAL REGISTER ELIGIBILITY  
OF THE VERMILION LOCK,  
VERMILION PARISH, LOUISIANA**

**FINAL REPORT**

**DECEMBER 1988**

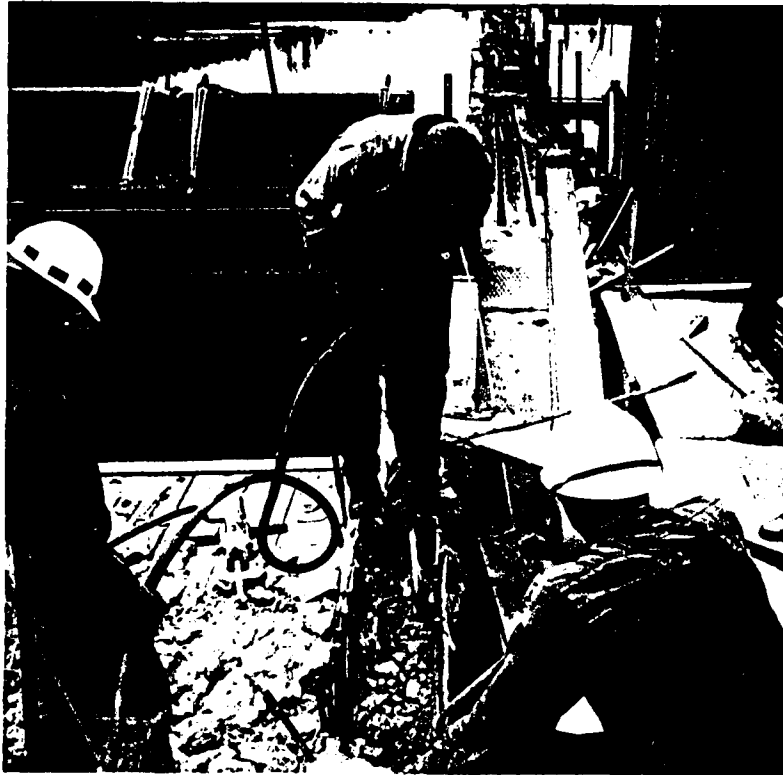
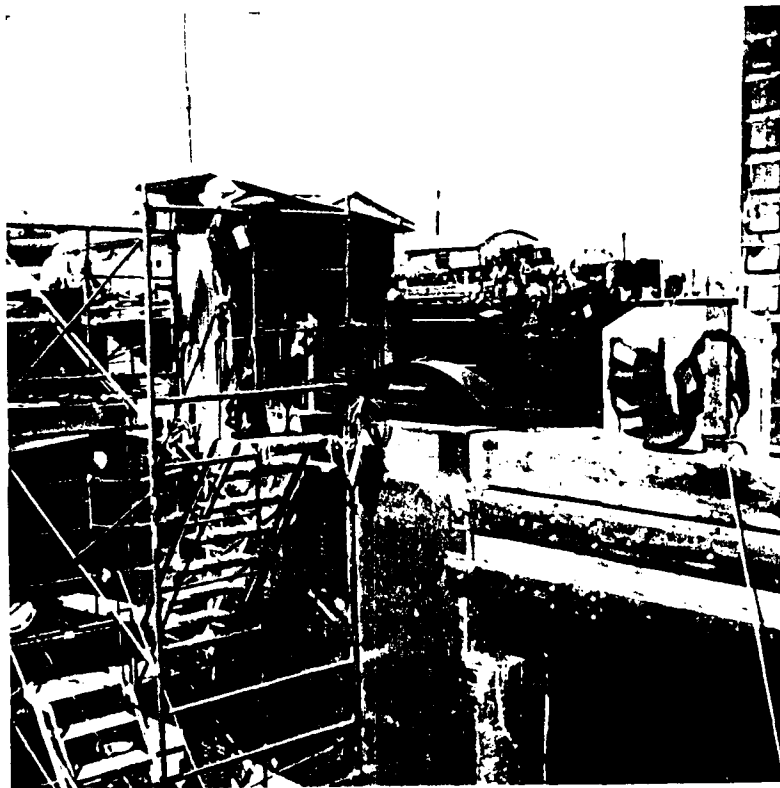
Although the damage was not excessive, many sections of the concrete gatebays were seriously worn. Most of the corners were chipped and worn round by constant rubbing and bumping. In addition, during a 1973 dewatering, it was noticed that at least two inches of concrete had been worn away below the waterline as a result of rubbing (Hugh L. Brownlee, Chief, Operations to Mr. Breerwood, Chief, Planning Division, 20 April

Figure 17. Jackhammering and subsequent modification to lock wall (Courtesy New Orleans District, C.O.E.).

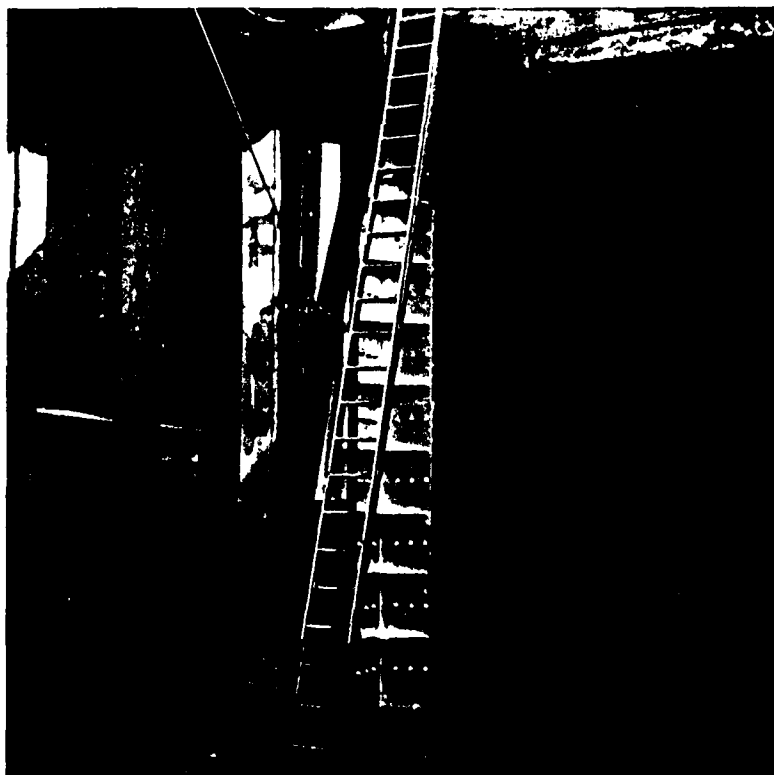
Figure 18. Steel corner added to lock chamber  
(Courtesy New Orleans District, C.O.E.).

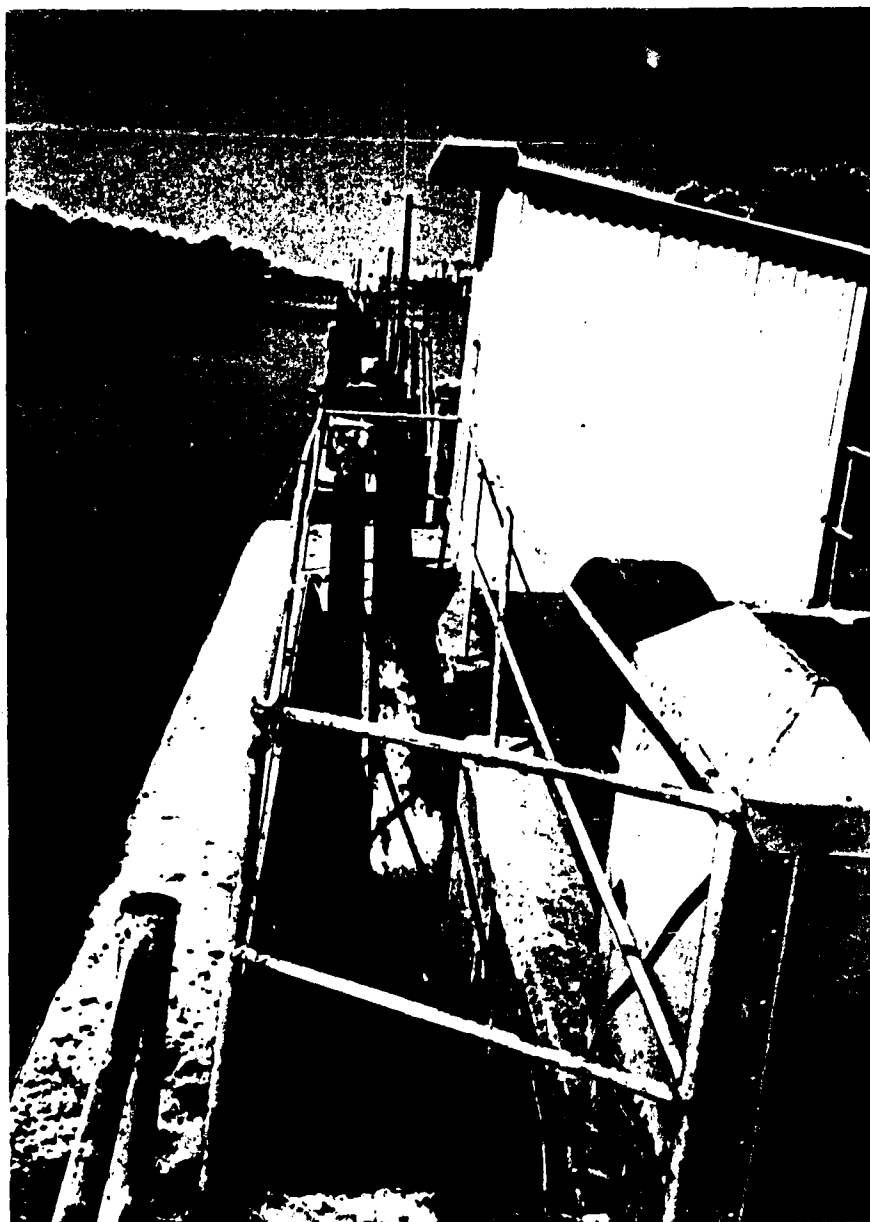
Figure 20. Added metal sheds enclosing gate machinery.

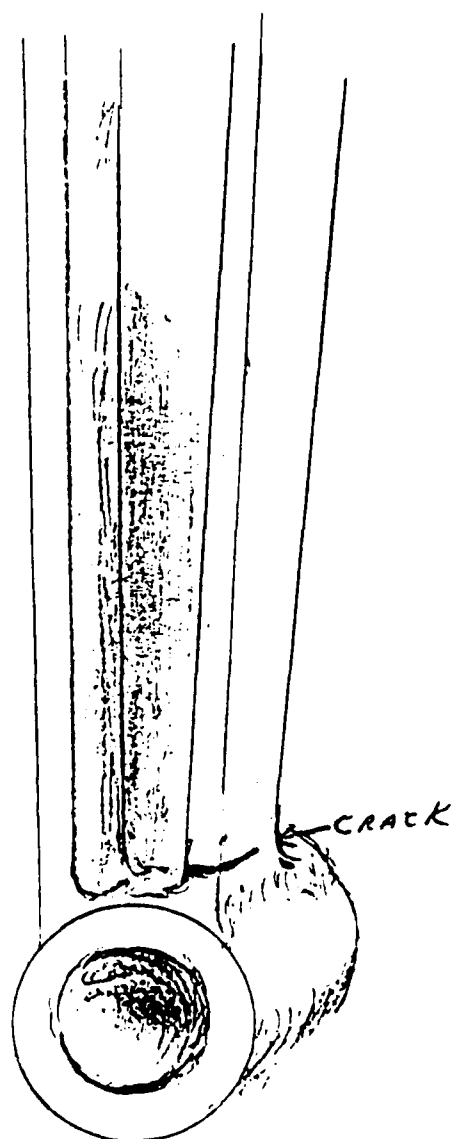
CRACK did not go  
through. The crack  
is where shown only.

Figure 24. Drawing of damaged arm section (C.O.E.  
Vermilion Files, F.Y. 74-75).

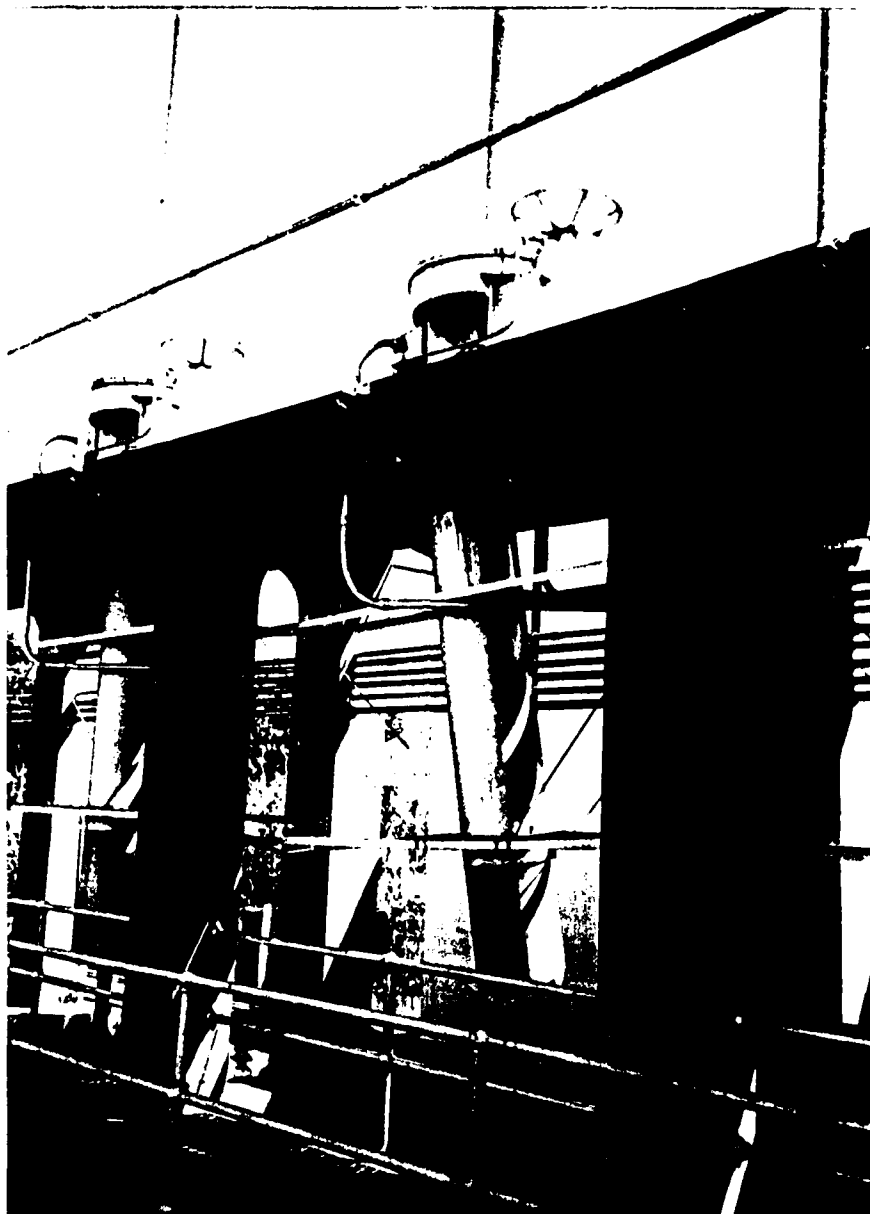
Figure 26. Askew valve gate at Vermilion Lock.
